# Tile Delamination on Façades of Tall Buildings

**Abstract:** Tile delamination on the façades of tall buildings poses significant concerns for public safety worldwide. This study investigates the underlying causes of tile delamination and their linkages with other prevalent façade defects in order to develop a risk assessment for preventing future tile delamination in tall buildings. Drawing on Singapore's experience, data were gathered from case studies through field inspections and expert interviews. The results have been supported by data findings and past laboratory testing conducted in the Singaporean context. The findings indicate that the main causes of tile delamination in Singapore's tall buildings are linked to design, workmanship, materials, and environmental conditions. Notably, cracks and water penetration often indicate a high risk of tile delamination, highlighting a strong connection between delamination's root causes and their frequent occurrence on tile façades. Finally, this study gives recommendations for designers, constructors, and maintenance teams to mitigate and eliminate risks associated with tile delamination, aiming to enhance the safety and durabilit

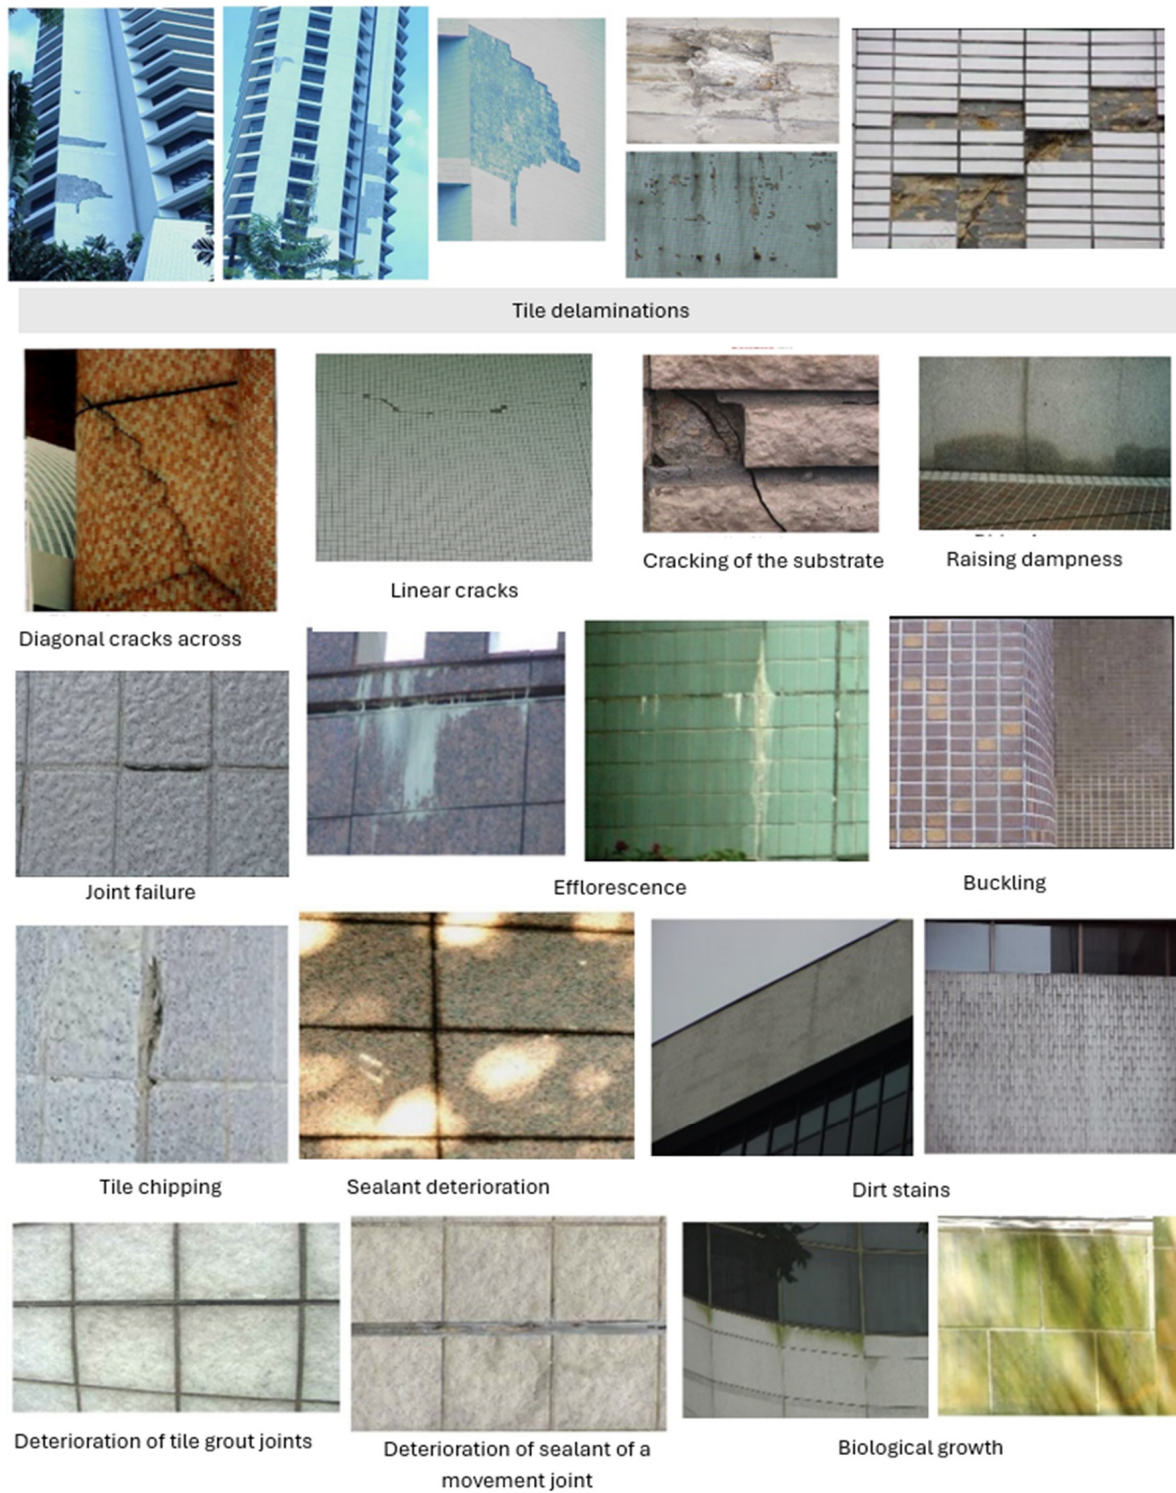
A large number of tile façade issues were discovered during the two-stage investigation into tile cladding in 160 buildings with tile delamination, and a few of them are depicted in Figure 6. The kinds of anomalies detected varied greatly in terms of their extent and root causes. For example, some cracks were horizontal whereas some others were diagonal (as illustrated in Figure 6), implying that the root causes of these cracks are indeed different. Further, delaminations had occurred due to the failure of various part of the tiling system of façades, such as substrates and adhesive layers.

**Figure 6.** Anomalies identified in tall buildings' tile façades.

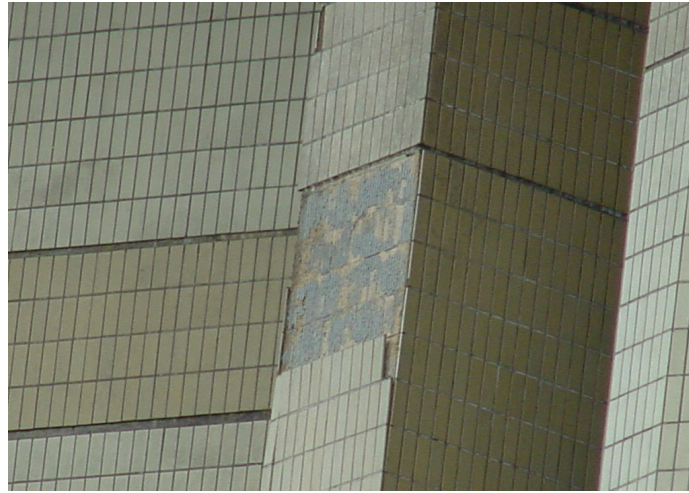
- Debonding of the plaster from the substrate (typically concrete) (Figure 7);
- Debonding of the tile from the bedding adhesive (Figure 8).

**Figure 7.** Debonding of plaster from substrate.

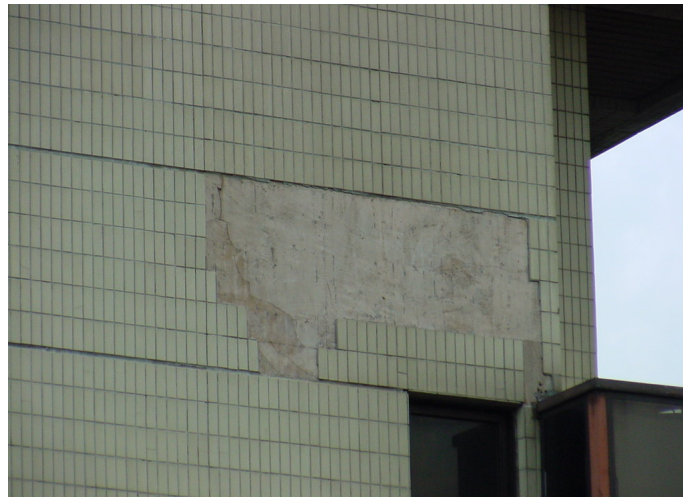
**Figure 8.** Debonding of tile from tile adhesive.

There were many cases in observed buildings where the bedding was poorly applied. Notched marks were seen on the bedding after debonding. In some severe cases, the tiles appeared not to have been adequately pressed onto the notched adhesive, giving little contact between the tiles and the notched adhesives. Notching has also been noted to have been carried out haphazardly in all directions, resulting in inconsistent coverage of the

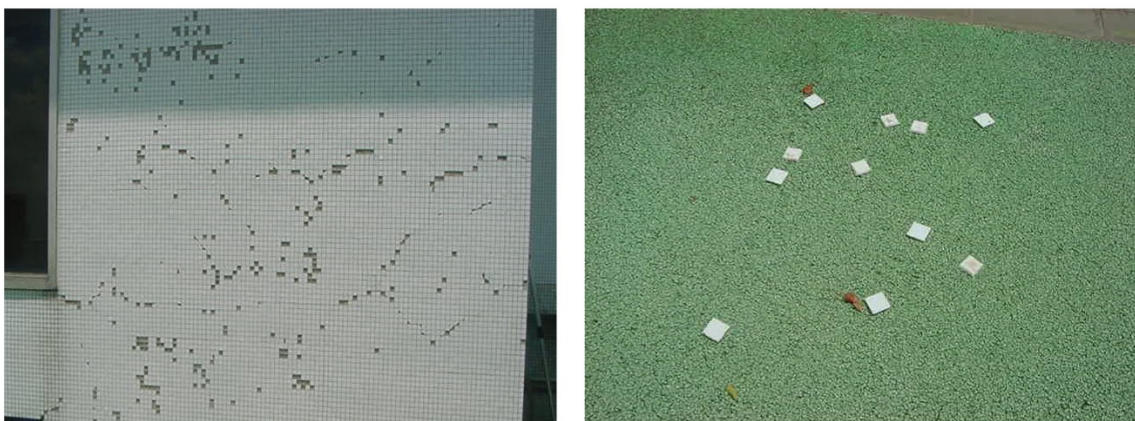
Cohesion failure within the plaster and bedding adhesive (internal failure within materials), as well as movement and corrosion of embedded metals, were also observed. For mosaic tiles, the common problem is the debonding of the mosaic from the bedding adhesive. This is understandably due to the inherent difficulty in bonding to the glass mosaic. The hazard of such failure may appear low for individual mosaic debonding (Figure 9), but can be serious if the debonding is in the form of a patch (Figure 10).

**Figure 9.** Random debonding of individual mosaic.

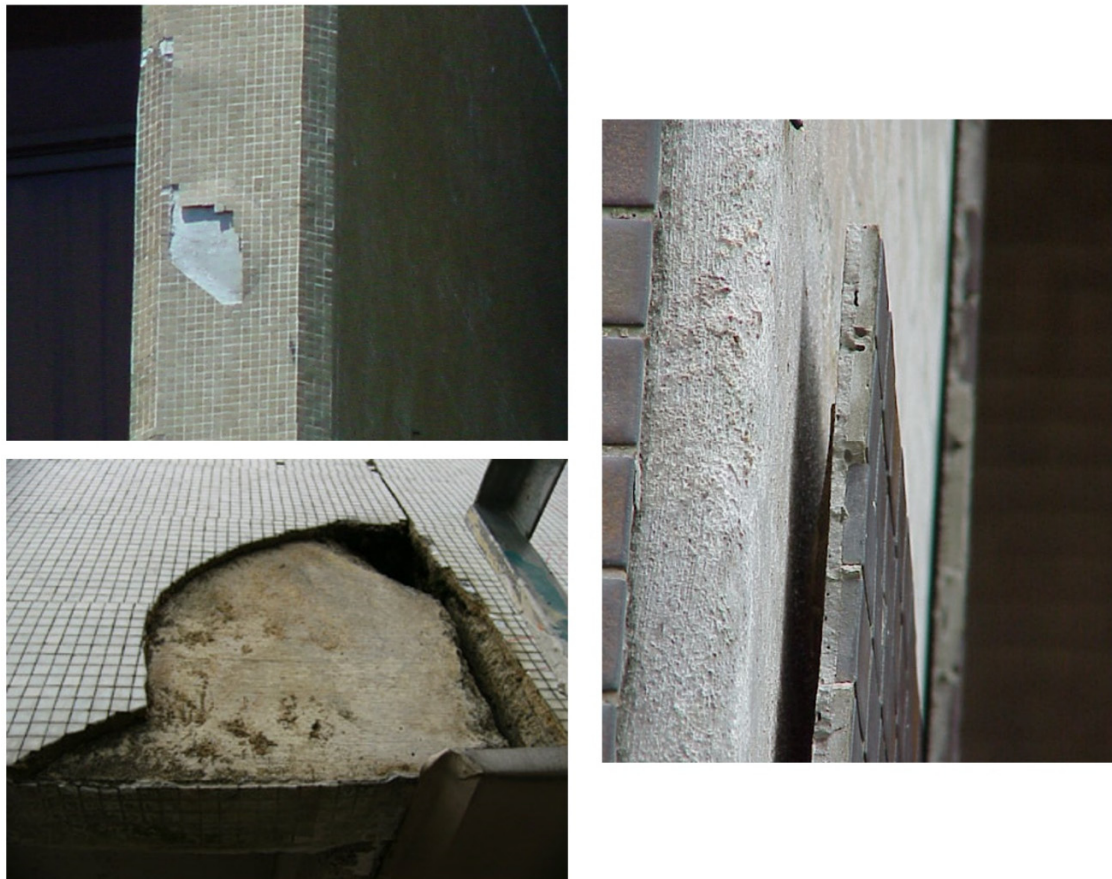
**Figure 10.** Debonding of mosaic in a patch.
