CONSERVATION TREATMENT RECORD

Lab number: 8141
Brief description: Cu Alloy Object
Name of owner: Martin Millet, Thwing Excavation
Owner's number: T05/16, 172

Name of student: Nyssa Mildwaters
Date allocated: 13th December 2006
Date completed: 16th March 2007

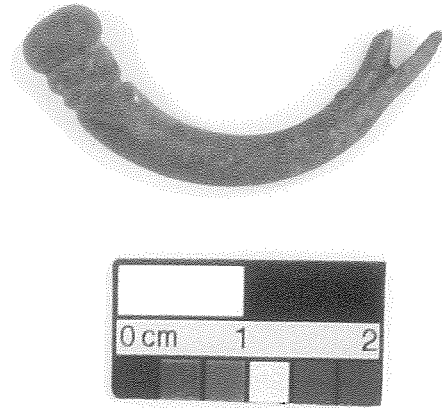
Lab Number: 8141
Cu Alloy Object
Before Treatment

Before treatment - The first and most obvious problem relating to the object was the relatively limited layer of soil adhering to the objects surface (Figures 1 and 2), as the presence of the soil on the surface of the metal may have helped promote further corrosion (Scott. 2002). Though in those areas free of soil the object appeared to be in a stable condition with an apparently uniform layer of the corrosion product malachite present, and no obvious areas of active corrosion. Second problem as discussed below is that x-rays of the object show the presence of a crack running through the object. However the crack was masked by the overlying soil and thus though the crack did not appear to compromise the objects overall structural integrity it was hard to evaluate this effectively whilst the soil was still in place. Out side of these specific problems the object did appear to be in relatively robust condition.

Figure 1. Photograph showing view A of the object before treatment.

The soil adhering to the surface of the object was removed using the application of swabs of IMS and a scalpel, particularly around the incised bands of decoration where swabs were insufficient to effectively remove the soil from the object. Though as the soil was relatively limited in its extent very little cleaning was actually required.

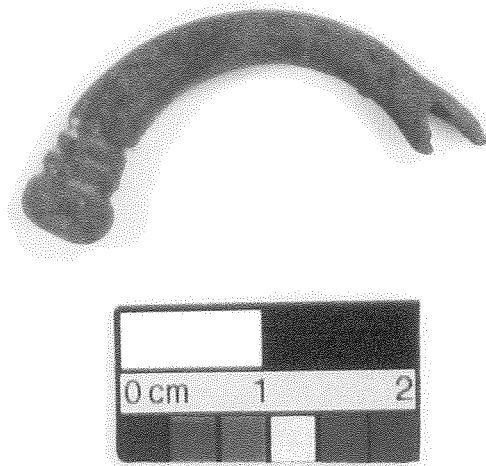
Lab Number: 8141
Cu Alloy Object
Before Treatment

Figure 2. Photograph showing view B of the object before treatment.

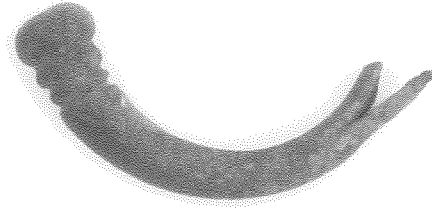
Lab Number: 8141
Cu Alloy Object
After Treatment

After Treatment - The object has been cleaned of all soil adhered to its surface and from the open end of the terminal (Figures 3 and 4). Revealing more clearly the crack evidence in the x-rays taken before treatment, though the crack does run for approximately 5 mm through the object it does not appear to threaten the structural integrity of the object or indeed to prevent handling of the object. Further more cleaning of the object has confirmed that there is no currently active corrosion present, though instead of a continuous malachite layer being present across the objects surface there are areas where the malachite is discontinuous and the brownish red corrosion product cuprite is clearly visible. Overall the object is in a relatively robust condition with no further remedial conservation requirements at this point in time.

Figure 3. Photograph showing view A of the object after treatment.

Finally as the object was likely to be handled, even though only in a limited manner given the lack of a secure archaeological context or a positive identification, several coats of Paraloid B48N (acrylate co-polymer) 5% in Xylene were applied to object to prevent further corrosion occurring and to provide some protection for the surface of the object during handling. Paraloid B48N was chosen to coat the object as it lacks the health and safety concerns associated with the use of and indeed the handling of object coated in BTA (Benzotriazole), an alternative option with regard to coating to object, whilst providing an effective corrosion inhibitor and barrier layer.

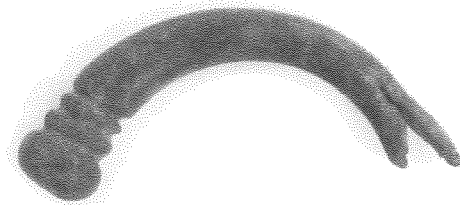
Lab Number: 8141
Cu Alloy Object
After Treatment

Figure 4. Photograph showing view B of the object after treatment.
