Madingley Hall, Madingley

Archaeological Monitoring and Recording of a new drainage installation

**MADINGLEY HALL,
MADINGLEY
Archaeological Monitoring and Recording**

Report No. 1509

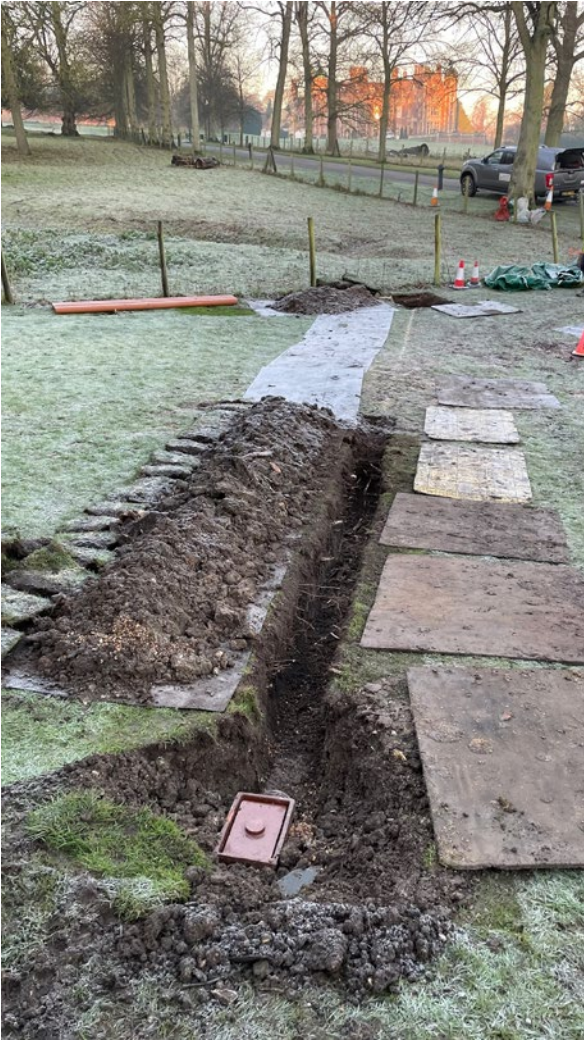
Figure 3. Northern segment of the trench, looking NW

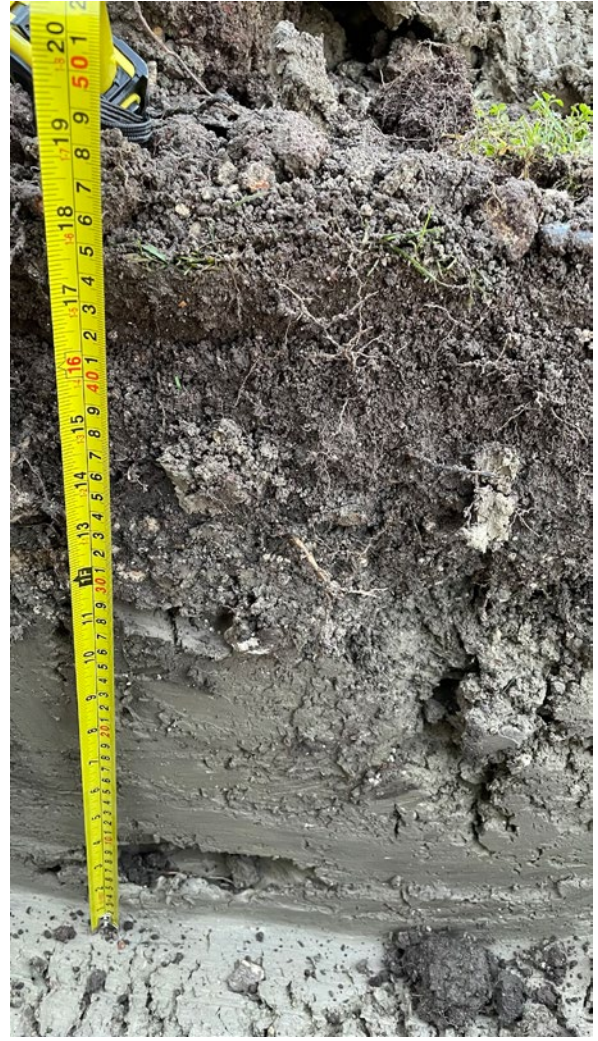
- 3.1.1 The full length of Trench 7 was covered by a thin layer of turf and by 0.15-0.2m deep topsoil [100] disturbed by tree roots.
- 3.1.2 In the southern part of the trench, the topsoil covered 0.2-0.3m deep pale brown grey clay with gravel, grit and rootlets inclusions [101] (Fig. 4).
- 3.1.3 In the northern part of the trench, [102] was similar to [101], but disturbed and mixed with dark grey silt, mortar and clunch fragments. It overlay a thin deposit of dark grey silty clay [103] (Fig. 5).
- 3.1.4 No finds or human remains were retrieved from the trench.

Figure 4. Section, looking W

- 4.1.3 The sequence in Trench 7 is very similar to the one exposed in Trench 1 and 5 (Aldred 2019): turf and topsoil overlaying a pale grey clay deposit related to the landscaping of Madingley Hall grounds by Lancelot 'Capability' Brown in the 1750s (Fig. 4). The creation of the Lake occasioned the excavation of a large quantity of soil that was used to level part of the grounds, the western part of the churchyard included. As the results of the present investigations showed, this levelling extended to the north-west of the Chapel as well. These results also demonstrated that both the church's and the Hall's grounds were landscaped equally.

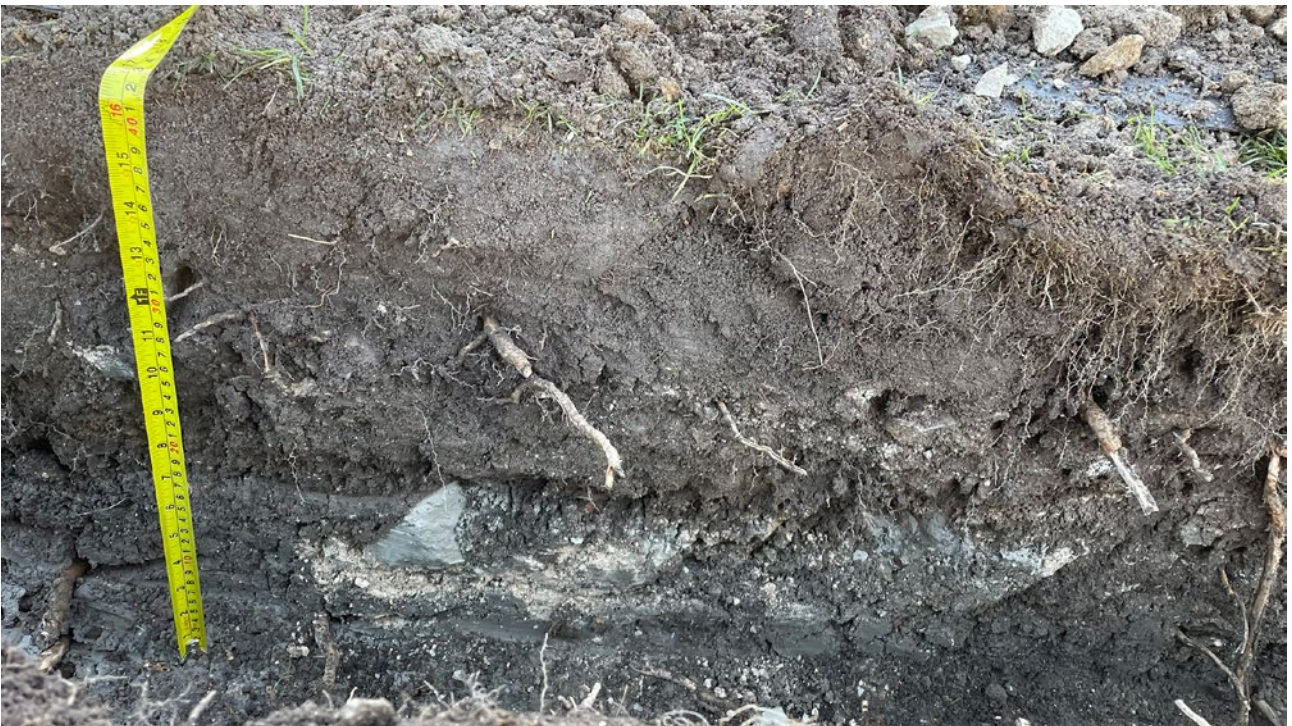
Figure 5. Section, looking NE

- 4.1.2 The sequence was rather homogeneous along the length of the trench, with lower deposit [101] becoming mixed and disturbed toward the north-west part of the trench (Fig. 5).
