# Tile Delamination on Façades of Tall Buildings

**Abstract:** Tile delamination on the façades of tall buildings poses significant concerns for public safety worldwide. This study investigates the underlying causes of tile delamination and their linkages with other prevalent façade defects in order to develop a risk assessment for preventing future tile delamination in tall buildings. Drawing on Singapore's experience, data were gathered from case studies through field inspections and expert interviews. The results have been supported by data findings and past laboratory testing conducted in the Singaporean context. The findings indicate that the main causes of tile delamination in Singapore's tall buildings are linked to design, workmanship, materials, and environmental conditions. Notably, cracks and water penetration often indicate a high risk of tile delamination, highlighting a strong connection between delamination's root causes and their frequent occurrence on tile façades. Finally, this study gives recommendations for designers, constructors, and maintenance teams to mitigate and eliminate risks associated with tile delamination, aiming to enhance the safety and durabilit

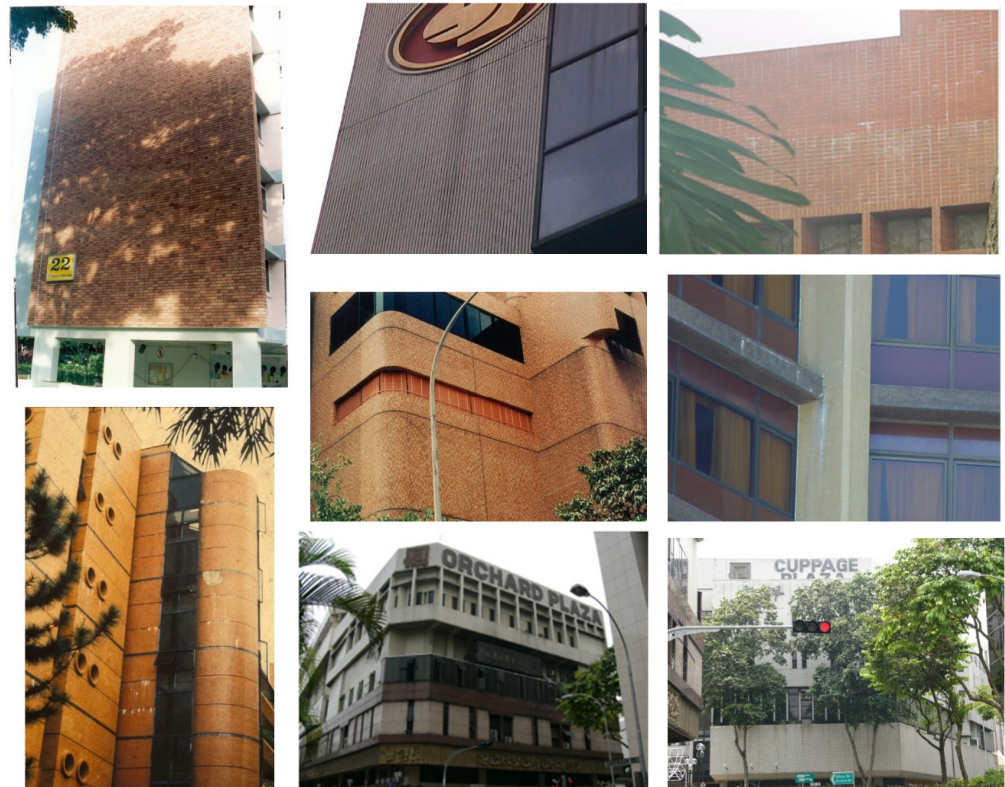
**Figure 1.** Mosaic and marble-tiled façades.

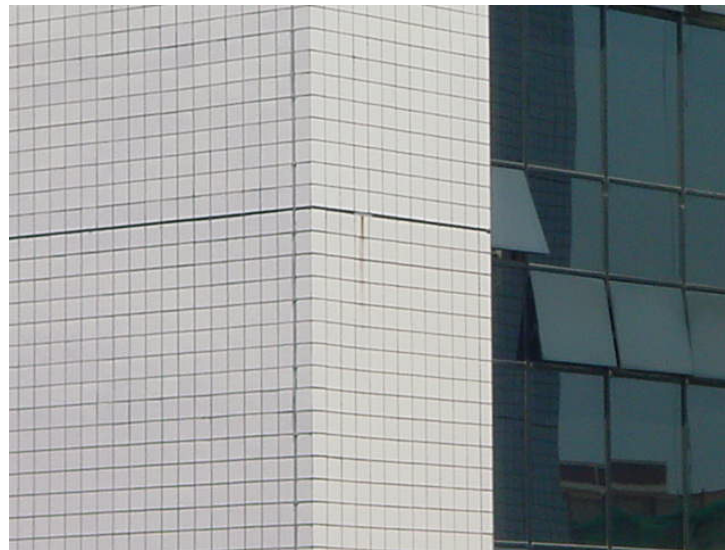
**Figure 12.** Movement joints of 6–10 mm width.

these joints must be installed over substrate movement joints to compensate for movement caused by substrate shrinkages and movements [32]. Where movement joints cannot be provided at all required locations, stainless steel mesh should be used to traverse areas of expected movement. Generally, movement joints of 6–10 mm width (Figure 12) are recommended for the following:

- Every 3 to 4.5 m in horizontal and vertical directions;
- At storey heights;
- Where the tiling changes directions or angle;
- Where tiles abut other surfaces and along existing movement joints in the structure;
- Filled with a stable sealant such as polyurethane

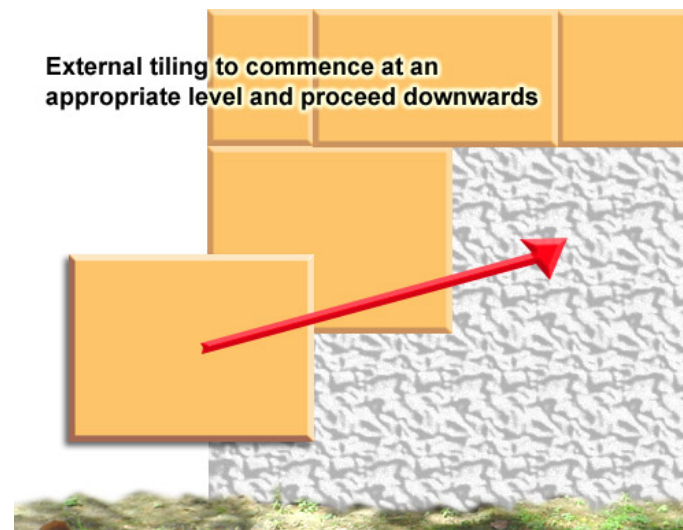
**Figure 13.** Sequence of tiling (red arrow indicating where the next tile needs to be installed).

External tiling work should commence at an appropriate level and proceed downwards. This will prevent contamination of completed tiling at lower levels from the works above. It also allows for quicker dismantling of scaffolding once tiling works at the upper levels are completed (Figure 13).

For multi-story construction, some form of deflection of the building may occur at lower levels due to increased loading with height. Hence, by selecting an appropriate level at which to commence tiling, movement due to deflection at the lower levels can be accommodated before tiling work begins. The substrate should be well-cleaned and free from dust, ready to receive the tile bed. When applied in hot and dry environments, the concrete substrate should be dampened and cooled with a wet sponge. The surface should also be surface saturated-dry. Too wet a surface will result in poor bonding. The substrate should also be adequately roughened so that the adhesive will bond. If this cannot be achieved, then a stainless-steel mesh should be mechanically secured to the substrate and the tile bed applied over it.
